The Impact of Ice Roads and Ice Pads on Tundra Ecosystems

National Petroleum Reserve, Alaska (NPR-A)

*Scott Guyer,
Bruce Keating and John Payne
Bureau of Land Management
Alaska State Office*

Determine if there are any impacts or the degree of impacts created from ice road and ice pad construction.

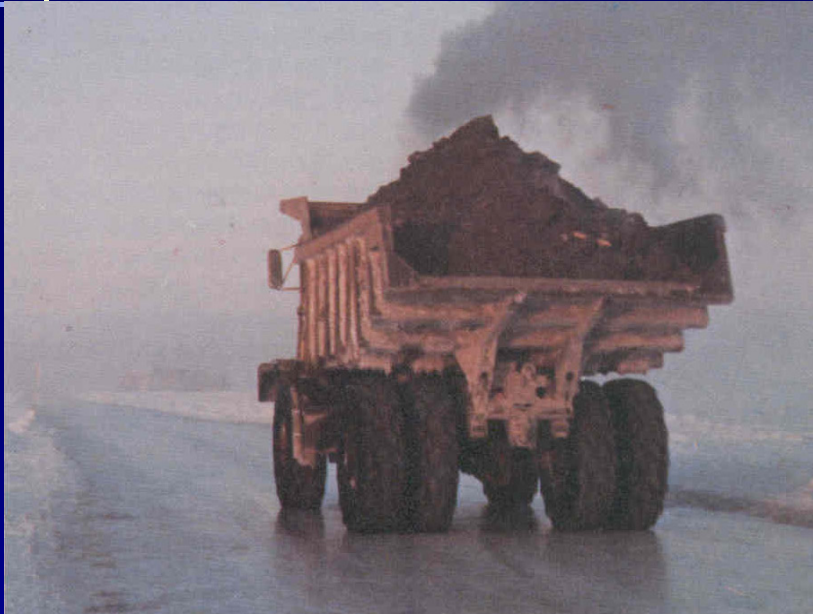
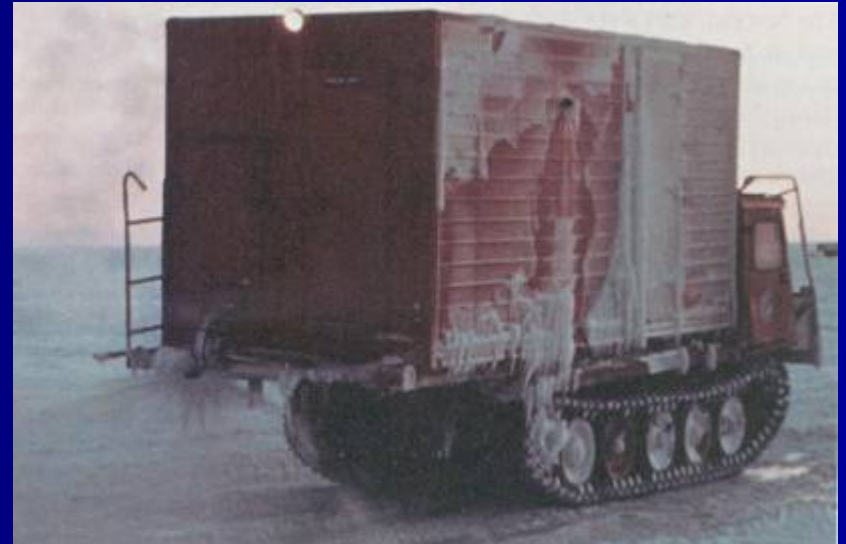
Inigok Ice Road 1978

- 37.5 miles of ice road.
- Construction began Feb. 1 and ended March 8.
- Gravel was hauled each day for 38 days.
- Total gravel hauled 132,000 tons.
- 35,000,000 gallons of water use to construct the road.

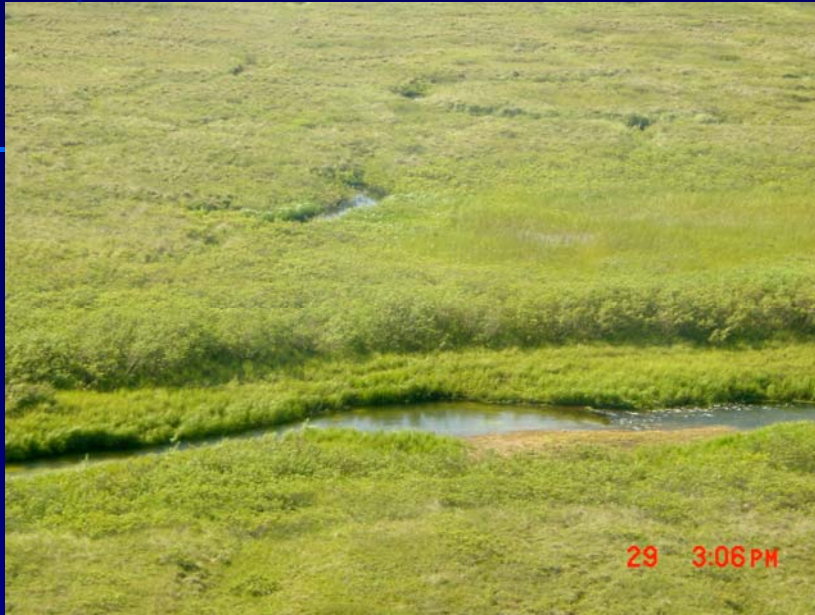
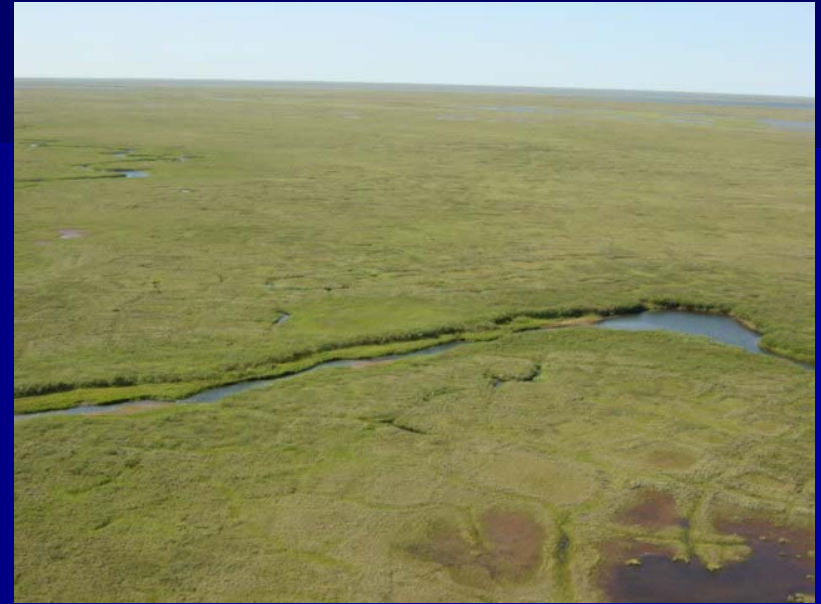
Depth to Permafrost Transect Inigok G

Looking West

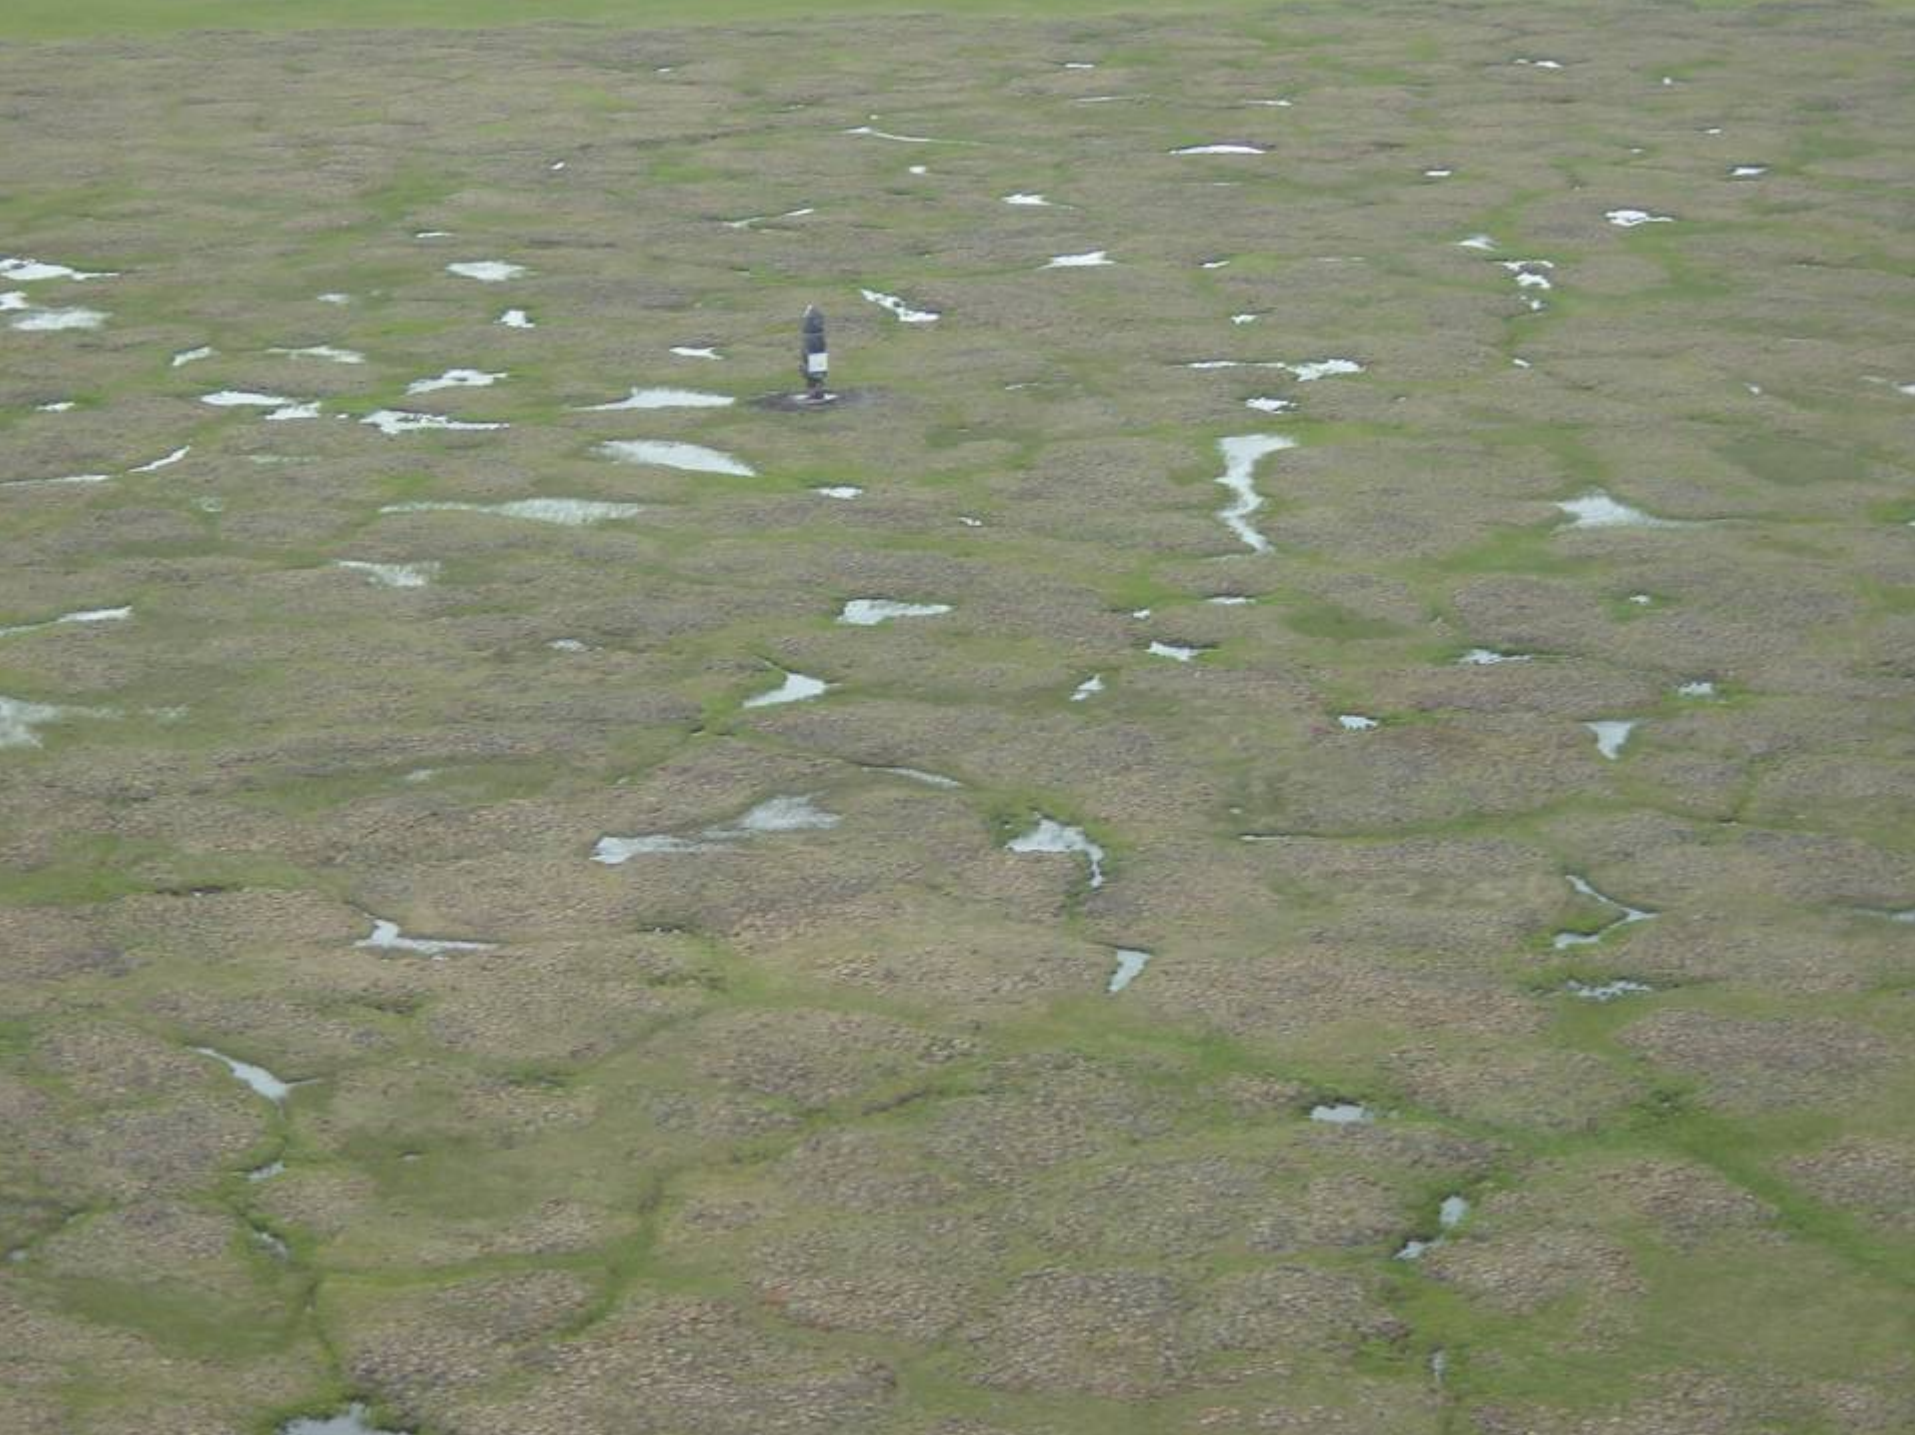
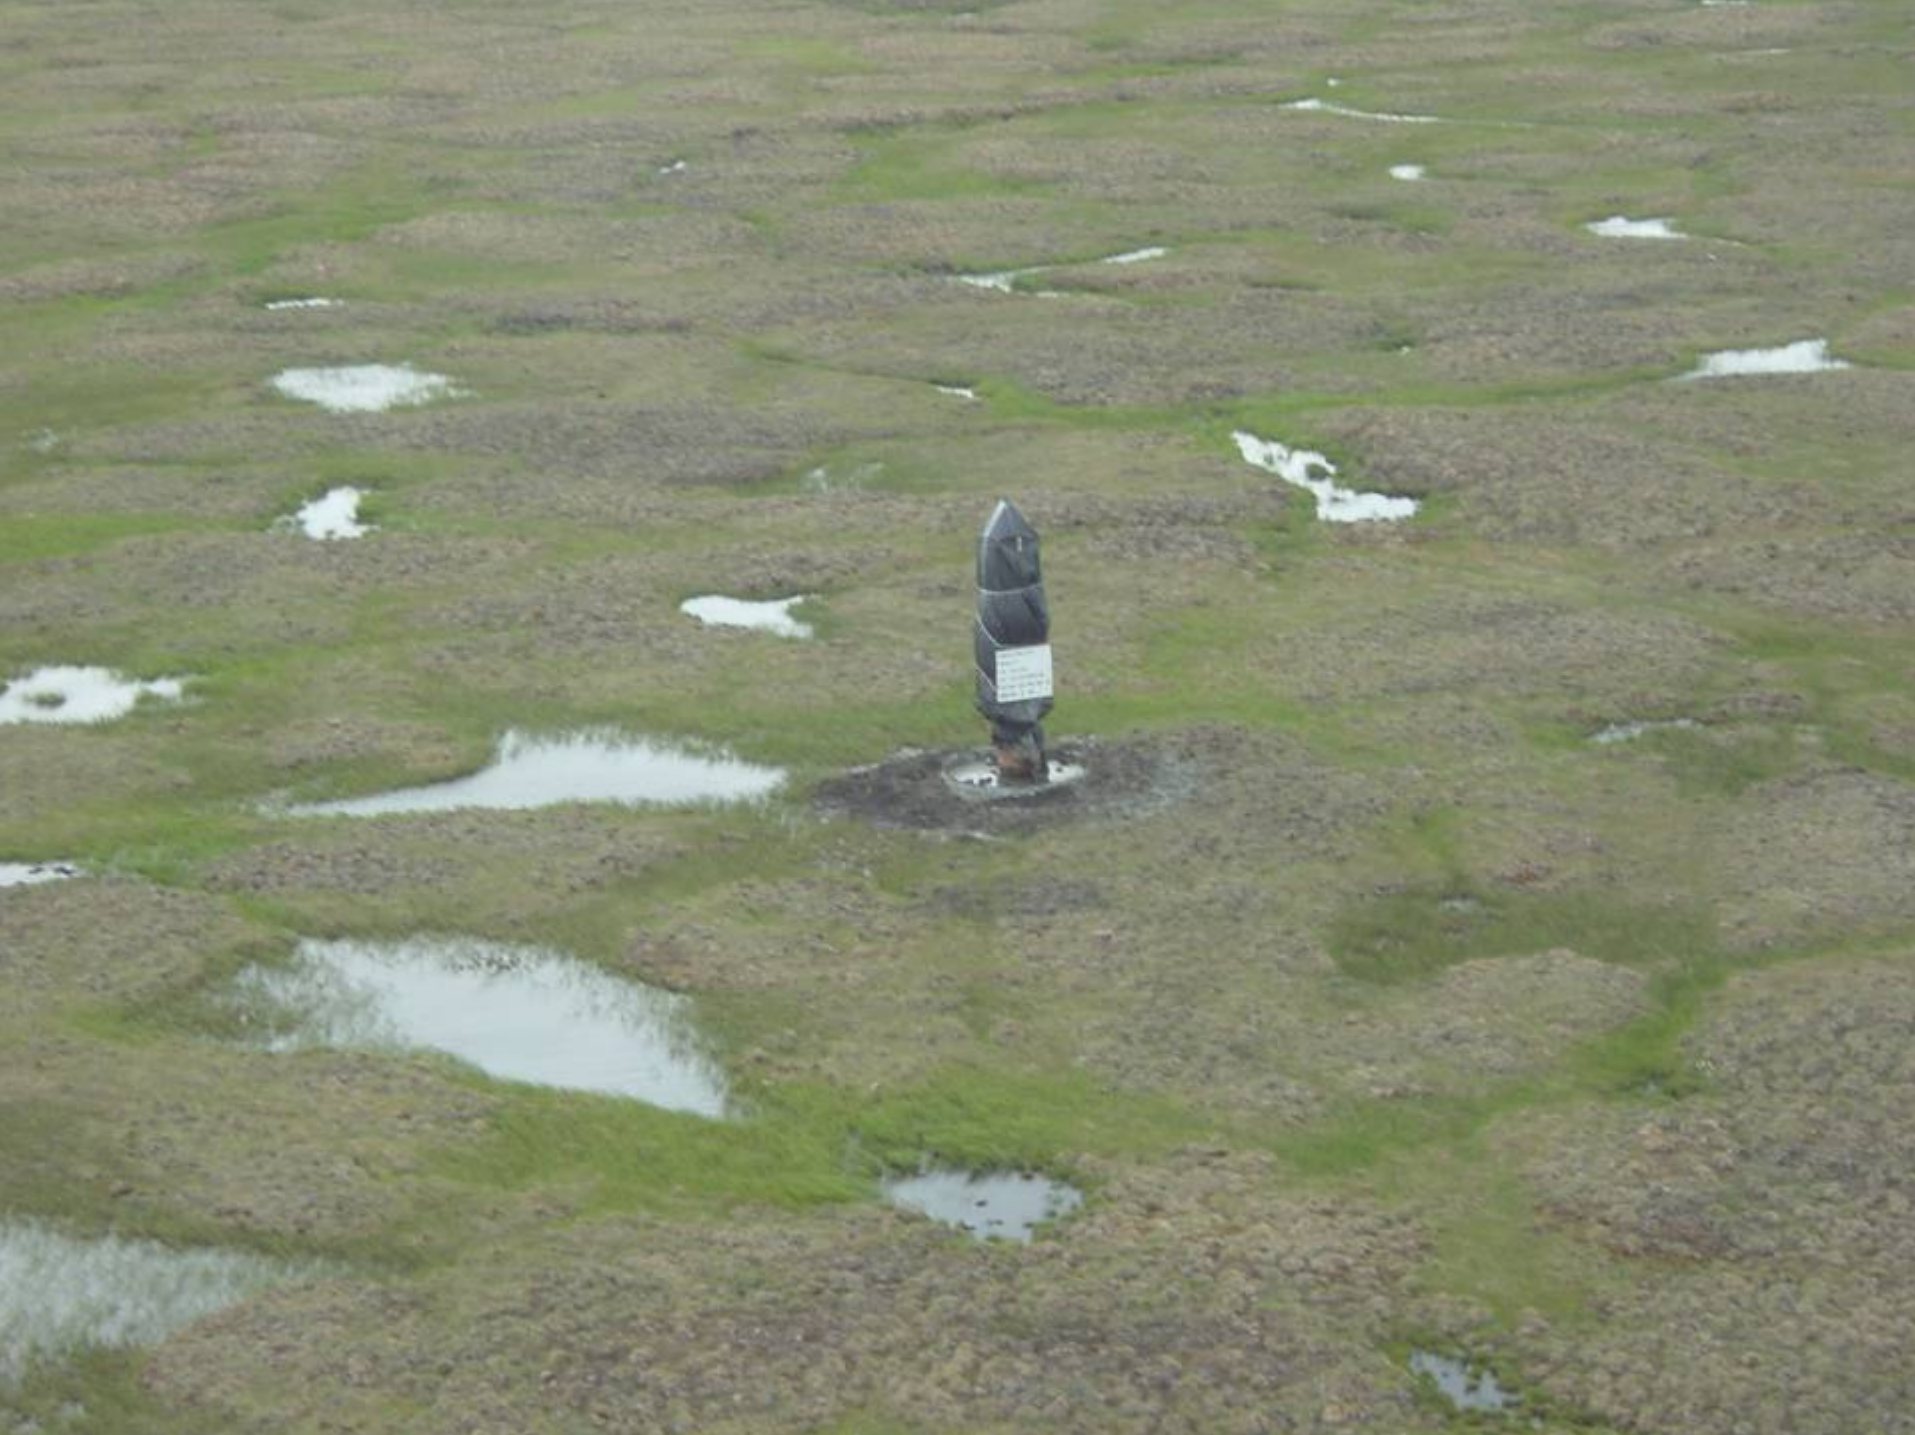
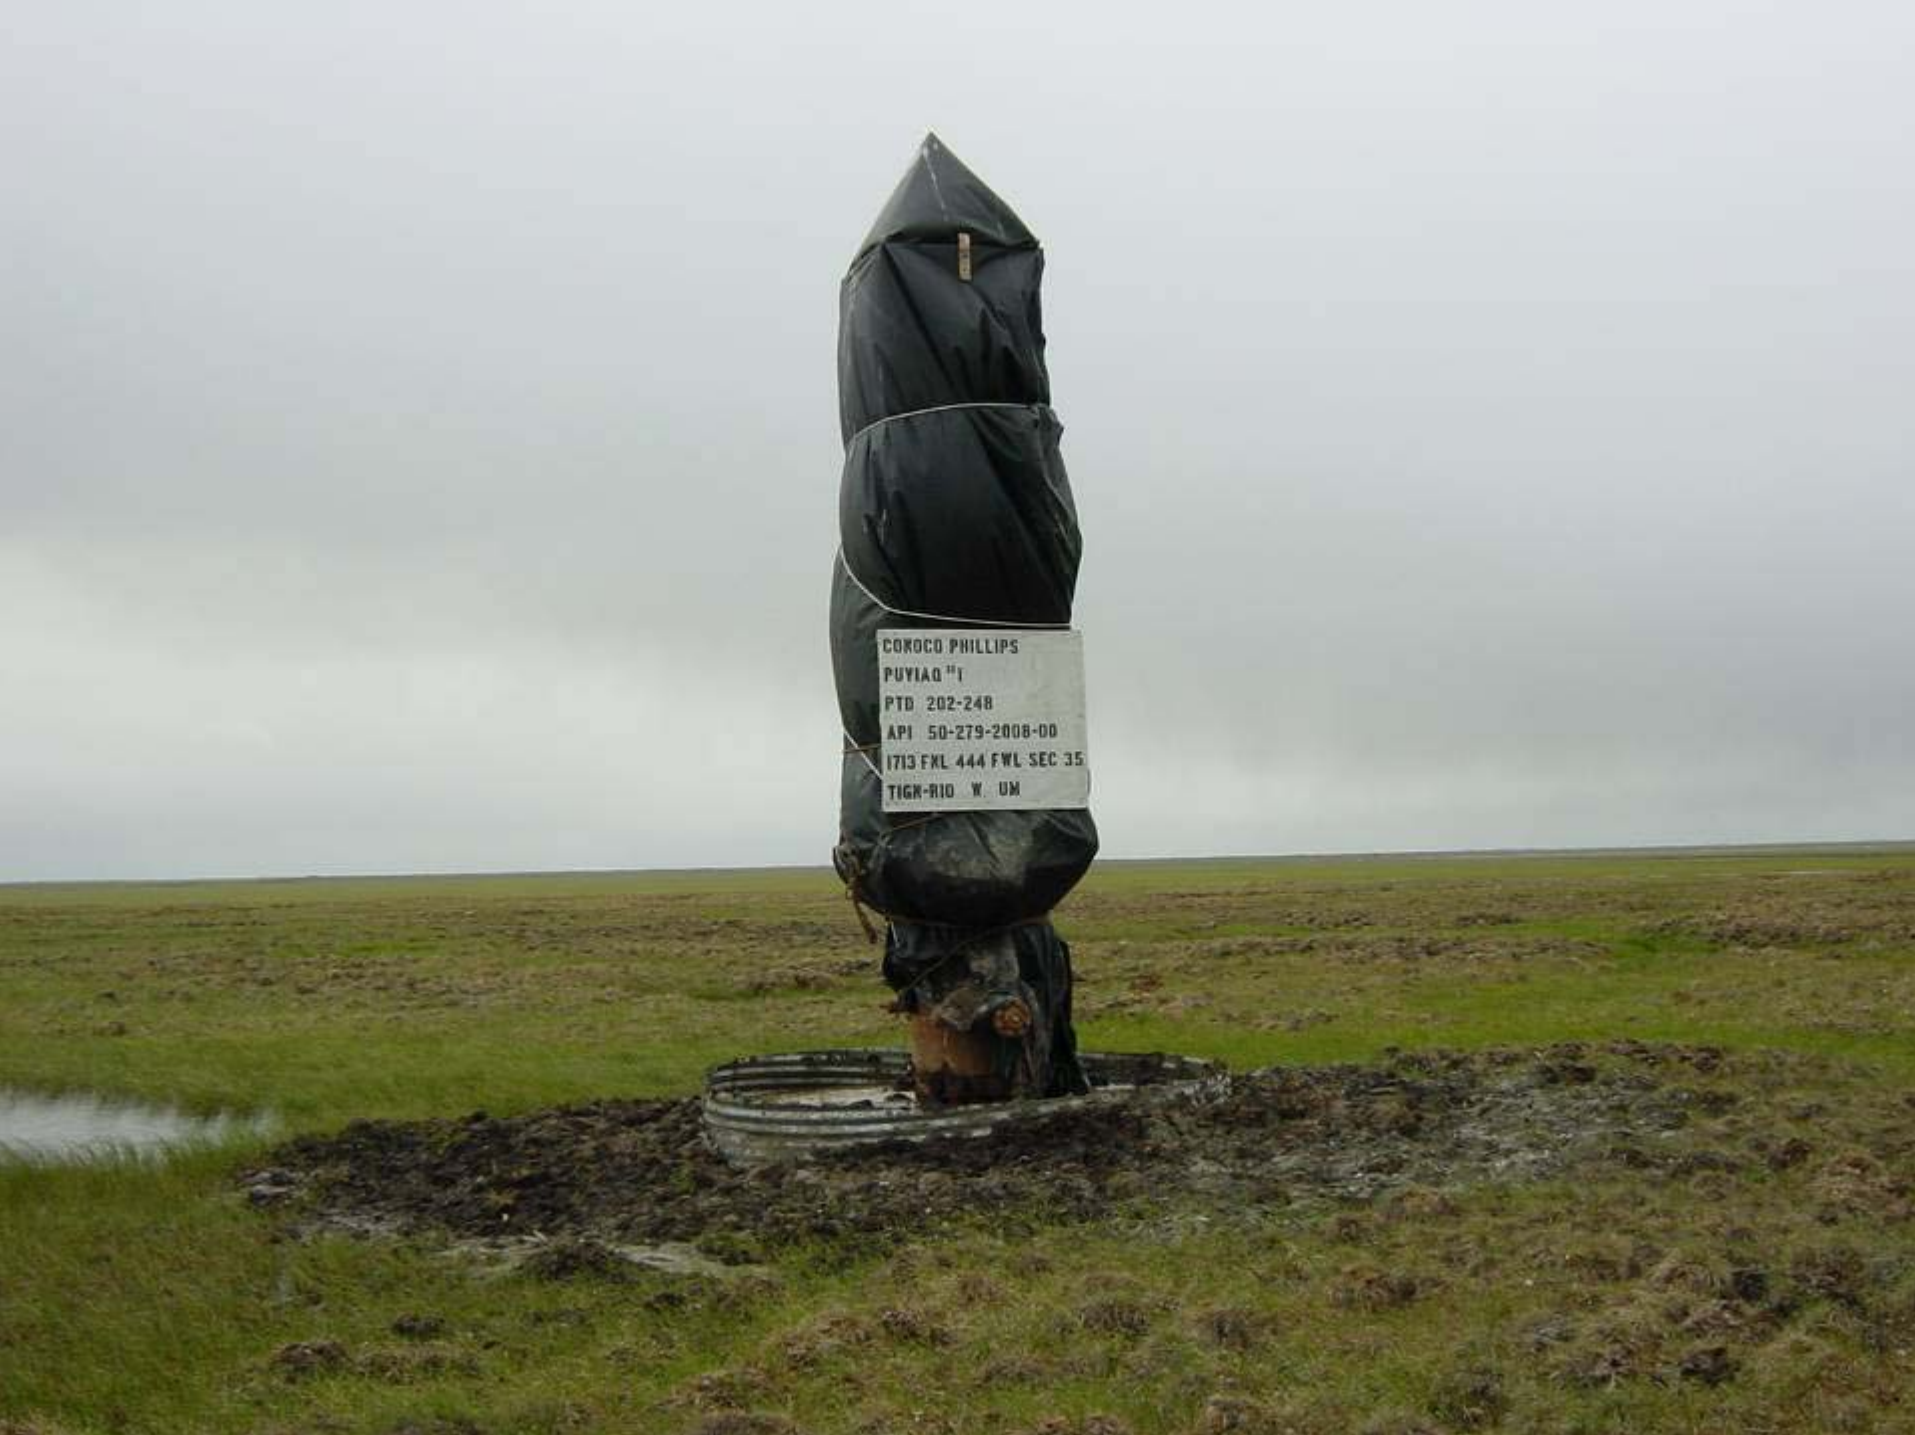
Puviaq Ice Pad July 2003

COROCO PHILLIPS
PUYIAQ #1
PTD 202-248
API 50-279-2008-00
1713 FNL 444 FWL SEC 35
TIGN-R10 W UM
